## B&M from page 1

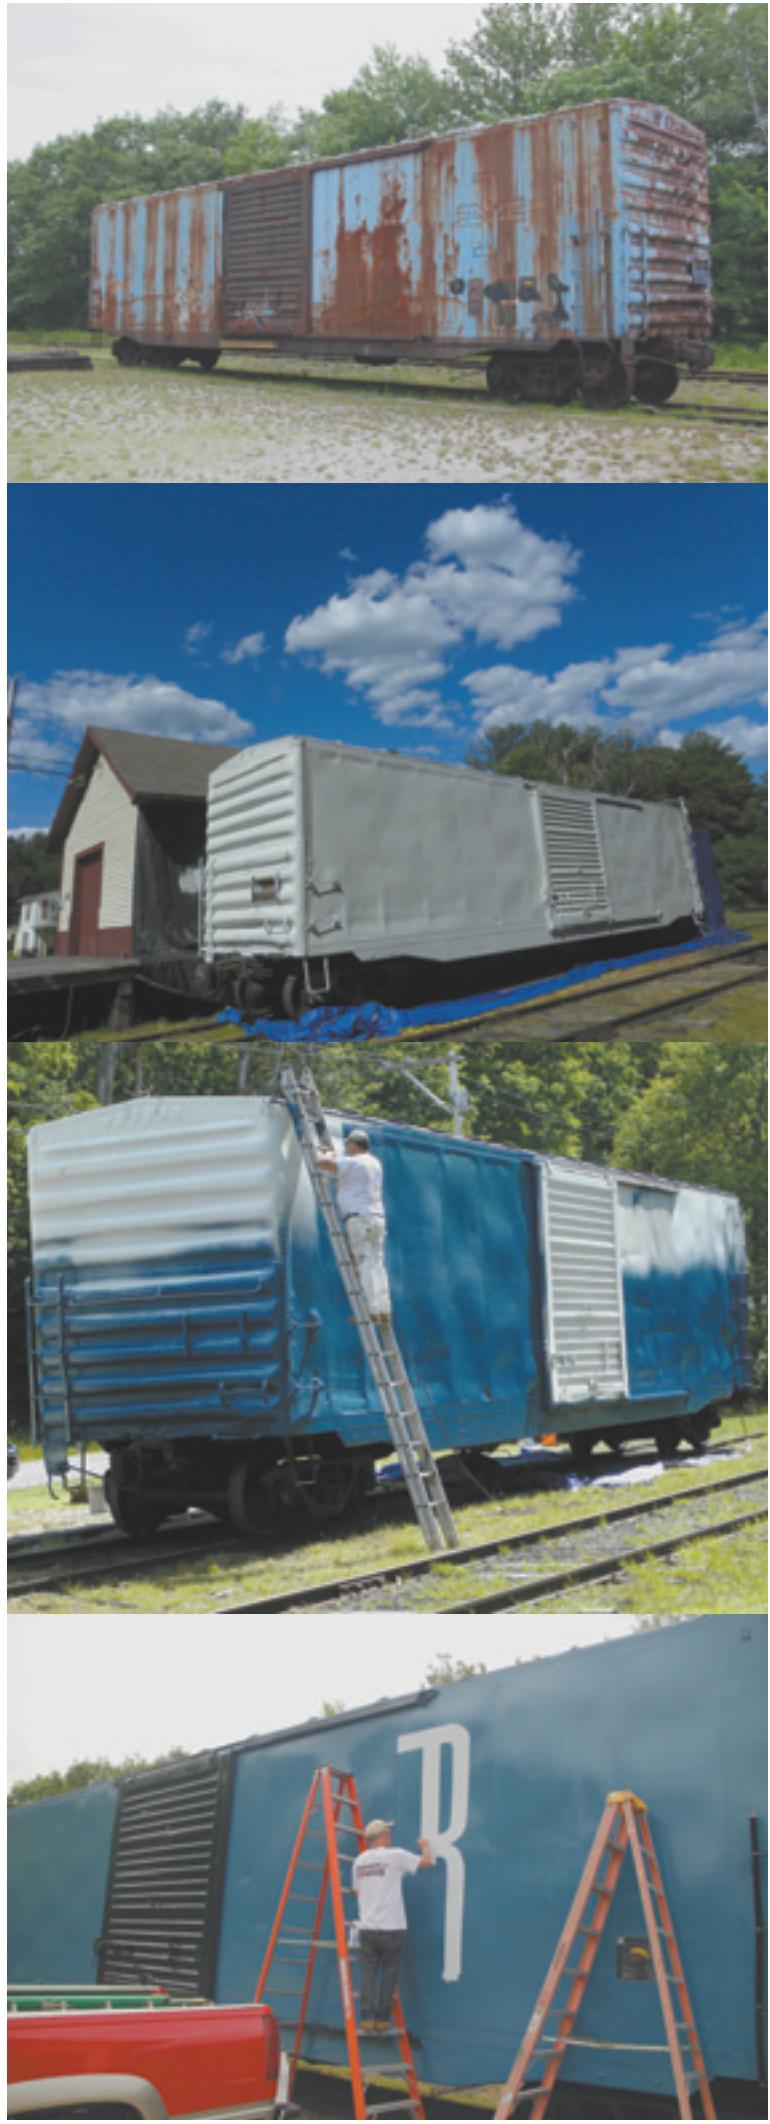
From the top: The condition in which the Andover Historical Society received the freight car after it sat for many years on a siding in Concord • Sandblasted, with two coats of epoxy primer applied • The authentic "boxcar blue" finish coat goes on • Dale Flewelling of Art Attack tackles the B&M logo, just in time for the freight car's unveiling at the Old Time Fair on August 5.

Ultimately, the committee decided the restoration should consist of sandblasting the entire superstructure except the top and underside, but to include the trucks. We would use two protective primer coats with an epoxy base specially formulated by Sherwin-Williams, followed by a finish coat of color. This combination would assure a high-quality, lasting finish. The last stage of restoring the lettering and logos was done separately.

On June 25, AHS contracted with Target NE, a historic restoration outfit in Alton, to start work. The car was completely sandblasted with appropriate safety equipment and techniques required to safely remove and dispose of the blasting aggregate and paint. A special sealant primer coat followed by an epoxy base second primer prepared the surface for the final color. Each primer was properly tinted to blend with our "boxcar blue."
